Manhole Inspection Summary

Manhole # S63A1_003MH

Location Address: **2200 Vail St.**

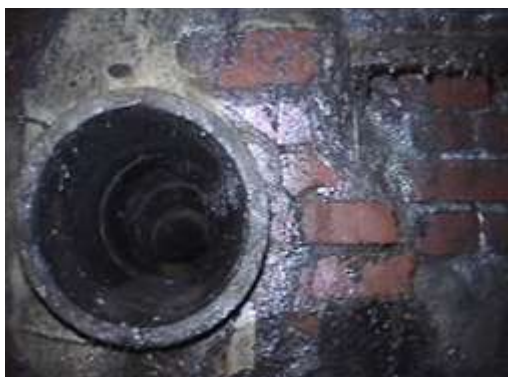
Defect 1

Cracked pipe seal. 11:00 on 3 o'clock incoming pipe

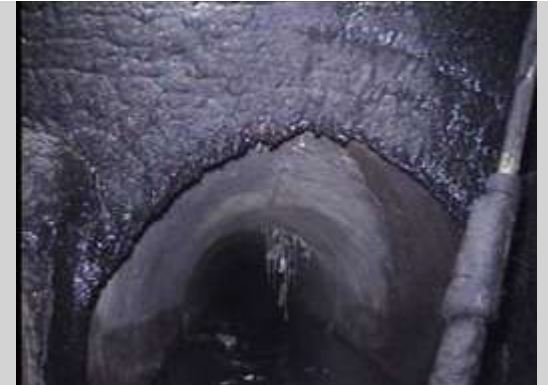
12 O'Clock Outflow

Pipe Height: **31.2** (in.) Rod and Bar (Angled)
Pipe Material: **Concrete** ☐ Pipe Lined
Invert Depth: **21.42** (ft.) Flow Characteristics: **Slow**
Deposits: ☐ None ☐ Mud ☐ Sludge ☒ **Debris** ☐ Grease
Silt Depth: **2.5** (in.) Deposits Extent: **Light**
Infiltration: **None** Pipe Seal Cond: **Sound**

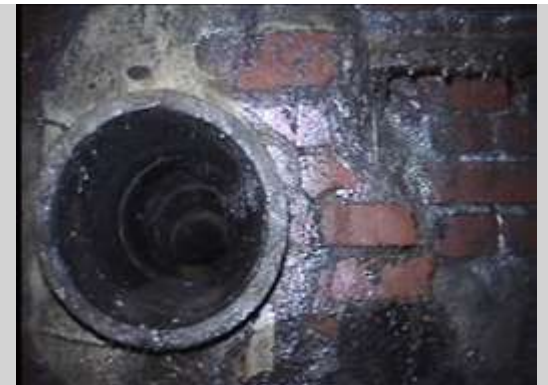
3 O'Clock Inflow

Pipe Height: **9.6** (in.) Rod and Bar (Angled)
Pipe Material: **Clay** ☐ Pipe Lined
Invert Depth: **14.33** (ft.) Flow Characteristics: **Slow**
Deposits: ☒ **None** ☐ Mud ☐ Sludge ☐ Debris ☐ Grease
Silt Depth: (in.) Deposits Extent:
Infiltration: **None** Pipe Seal Cond: **Cracked**

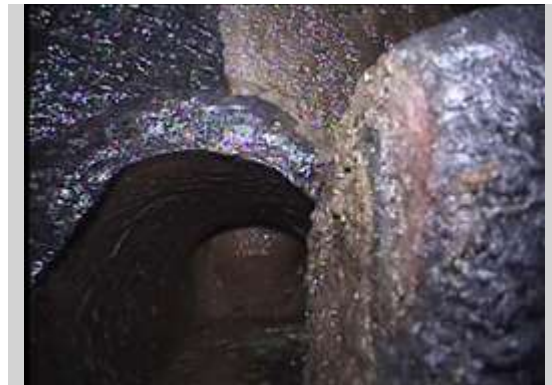
Drop In @ 3 O'Clock

Drop: **Outside** **Rod and Bar**
Angled: **Yes** Reading: **18.92** (ft.)
Inv Depth: **19.92** (ft.)
Drop Condition: **Open**

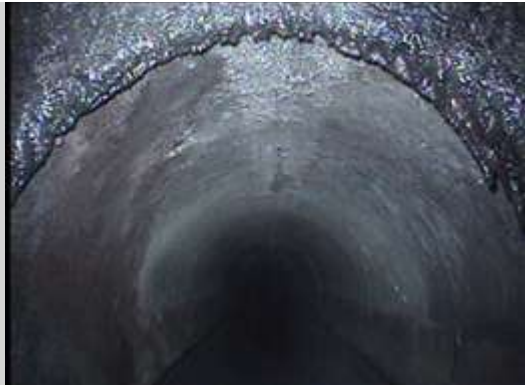
6 O'Clock Inflow

Pipe Height: **32.4** (in.) Rod and Bar (Angled)

Infiltration: **None** Pipe Seal Cond: **Sound**

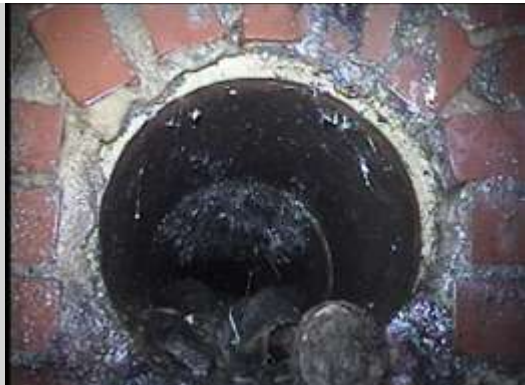
9 O'Clock Inflow

Deposits: ☐ None ☐ Mud ☐ Sludge ☒ **Debris** ☐ Grease

Silt Depth: **2** (in.) Deposits Extent: **Medium**

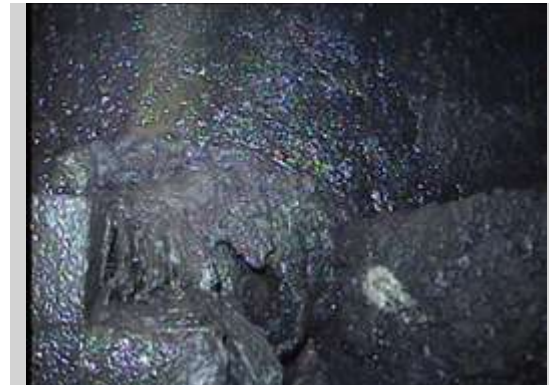
Drop In @ 9 O'Clock

Appears pretty clogged

Drop Condition: **Clogged**
